# PHOTOGRAPHIC MISSION REPORT

Tacuarembó-Salto Transmission Line  
February 27th - March 1st, 2023

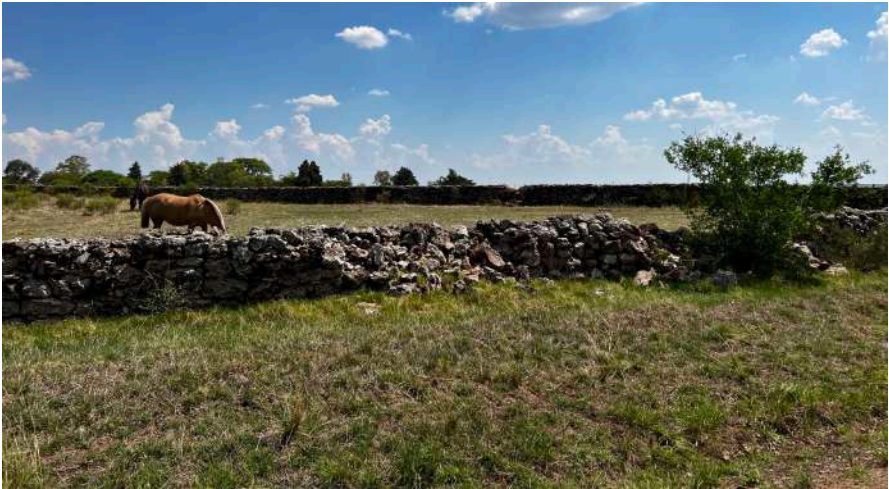
Stone wall/fence at private land (farm) by the road to the Morató village. Note partial collapse.

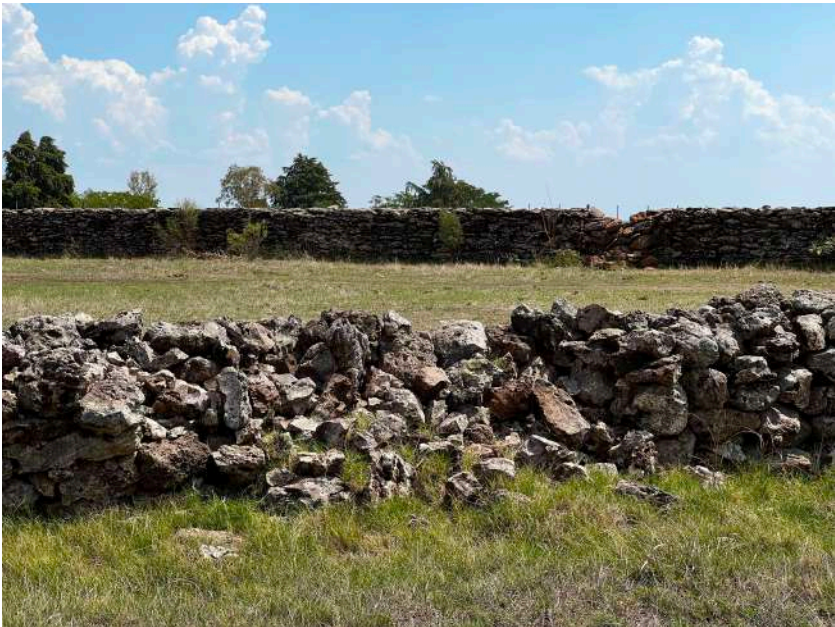
Stone wall/fence naturally collapsing at private land by the road to the Morató village.

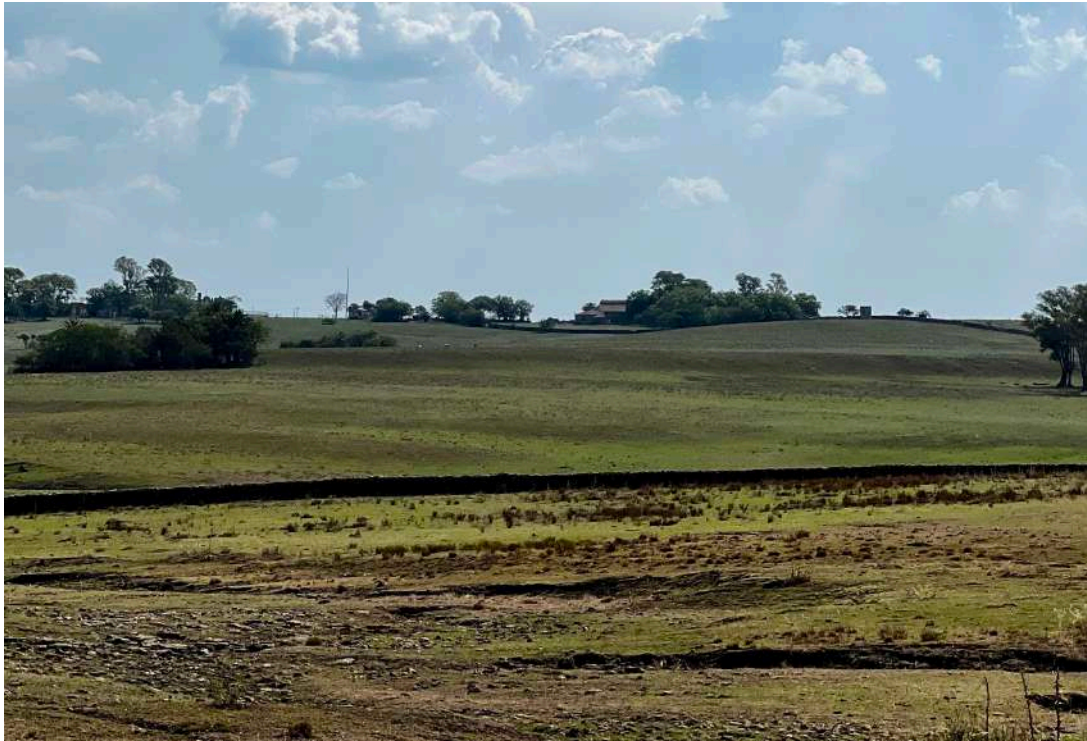
View of the one of the collapsed sections of the stone wall (documented collapse before the project ever started) at Estancia Buen Retiro. Note that the fence was installed over the stone wall foundation.

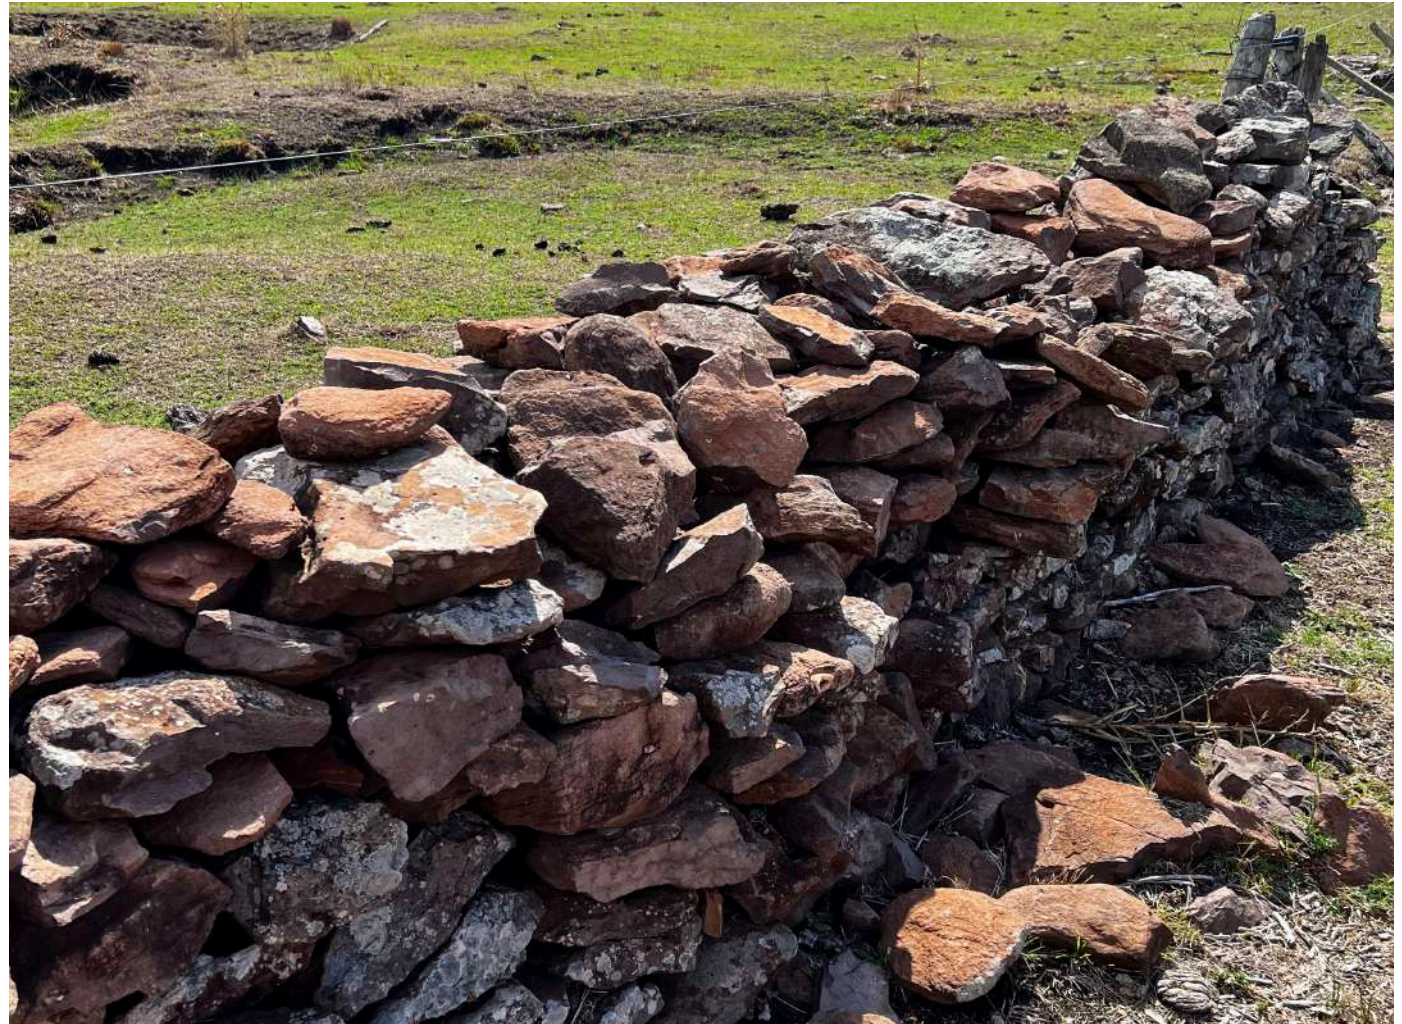
View of a section of the stone wall at Estancia Buen Retiro where the wall had previously been reconstructed by farm workers. Note the different color of the stones.

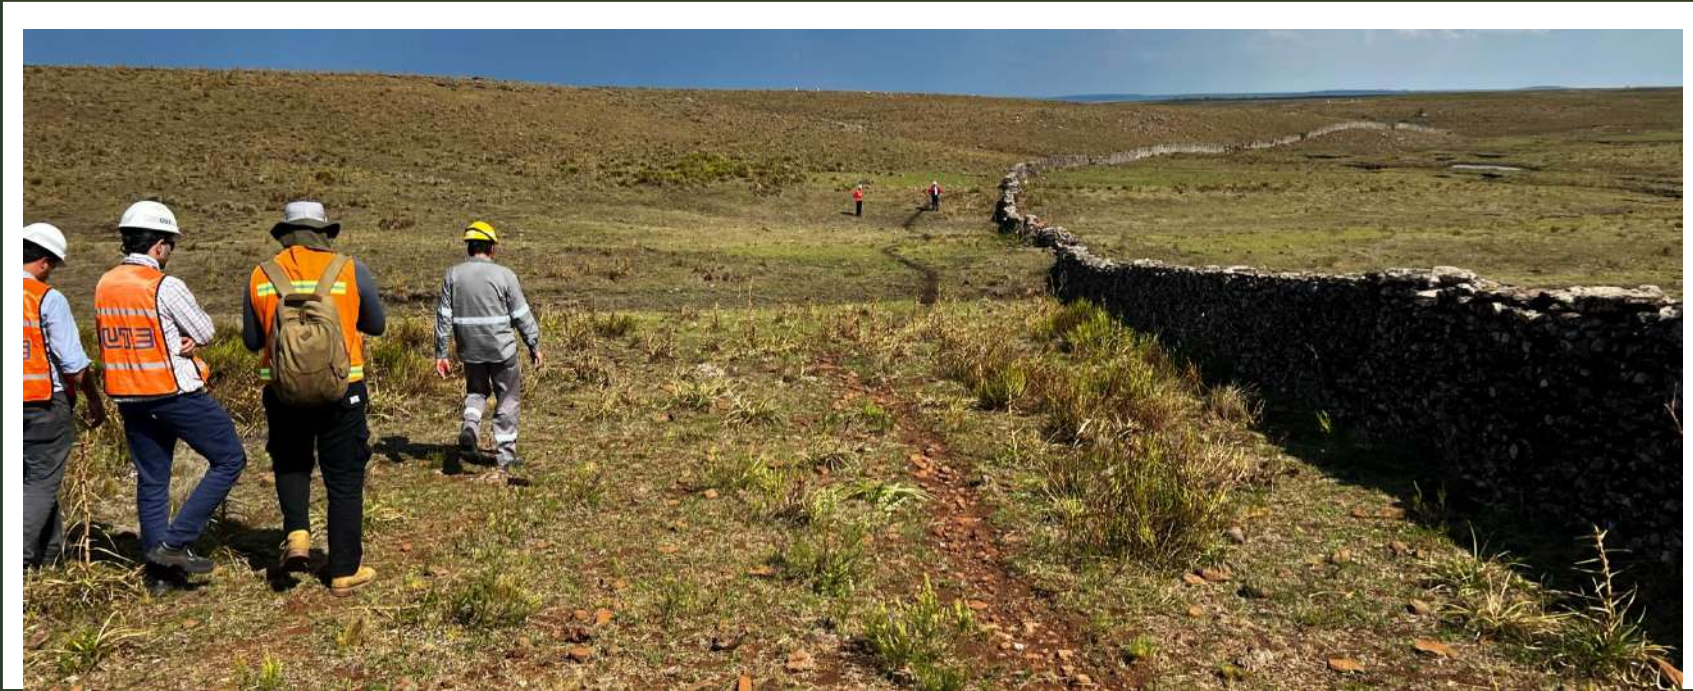
Mission members walking towards a low drainage point where the stone wall has partially collapsed - alleged affected by the project.

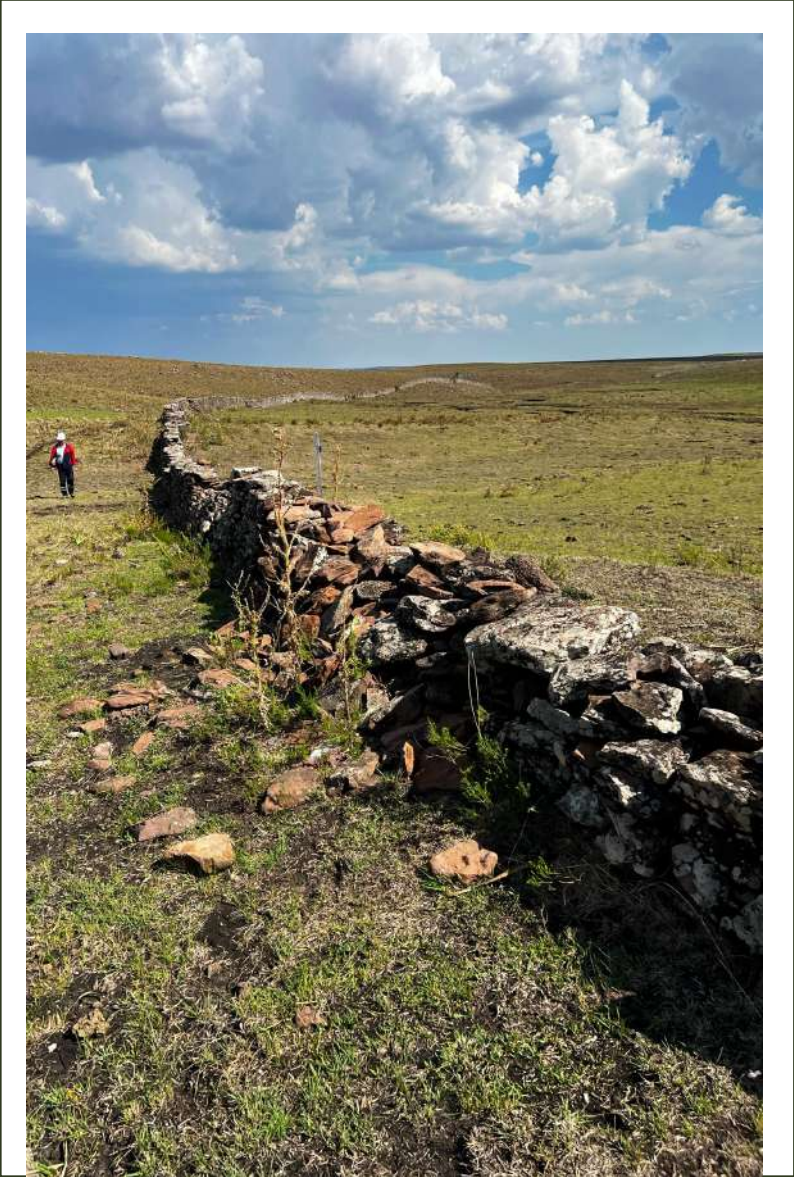
View of stone wall at Estancia Buen Retiro with several collapsed sections (most of them documented prior to project) with a section that had been reconstructed by farm workers in the foreground.

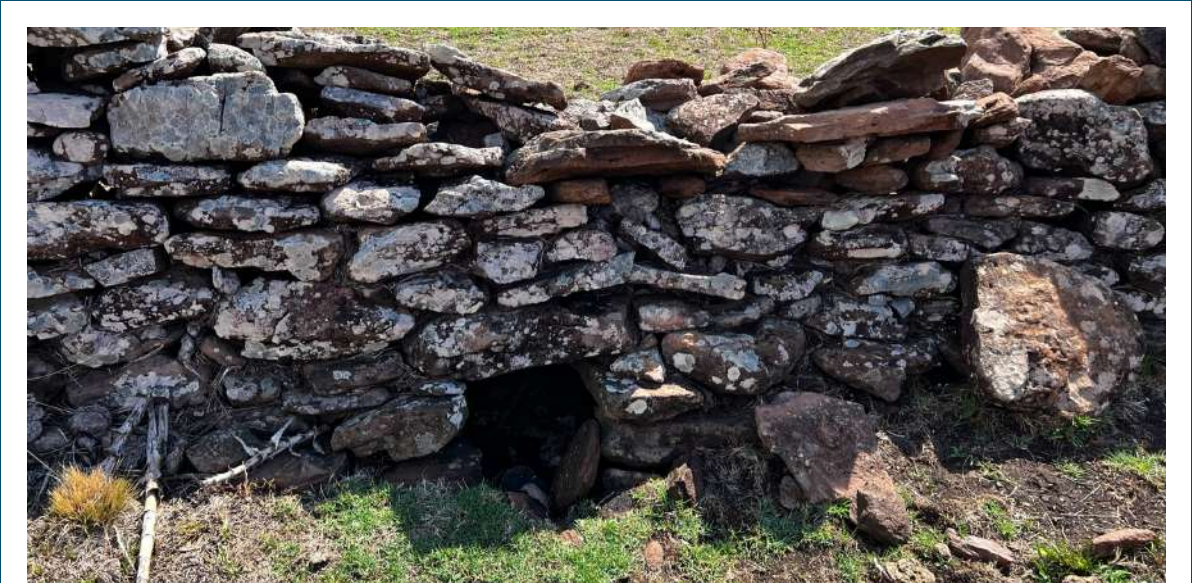
View of stone wall at Estancia Buen Retiro with drainage structure partially blocked.

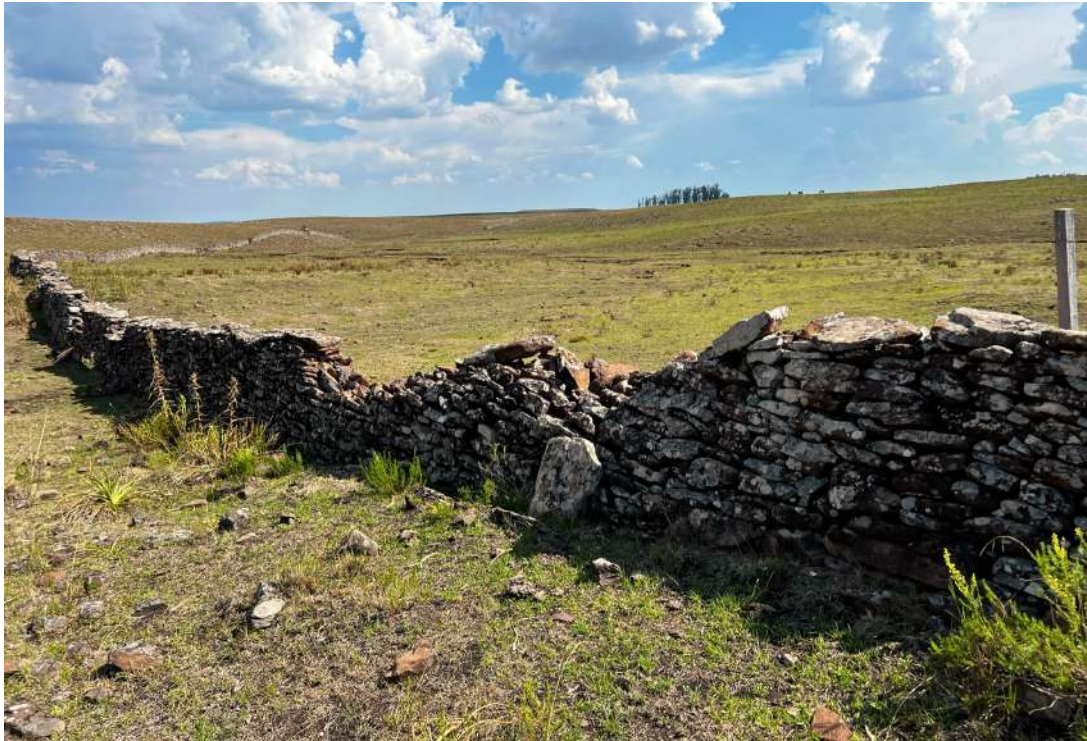
View of stone wall at Estancia Buen Retiro with collapsed sections. Note that the collapses occur with the same general section of the wall and that all of collapses point to one side opposite from the water drainage direction.

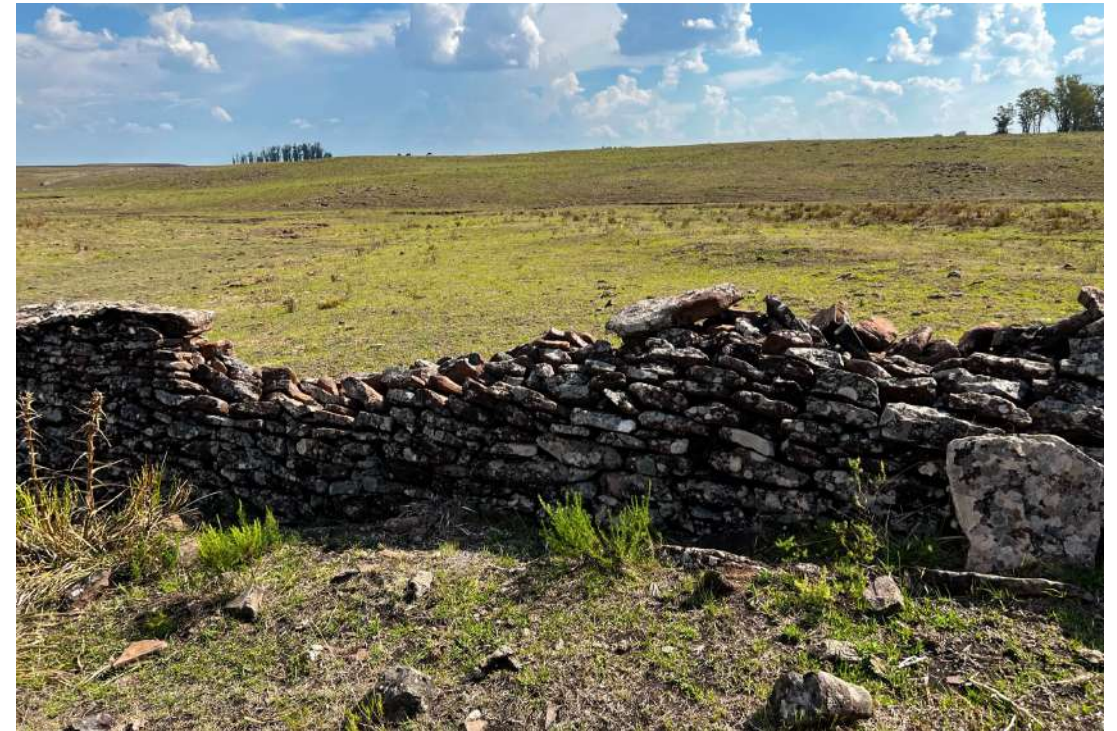
View of the stone wall at Estancia Buen Retiro where a collapse had happened. Note that the water drainage system is almost entirely blocked by vegetation and debris.

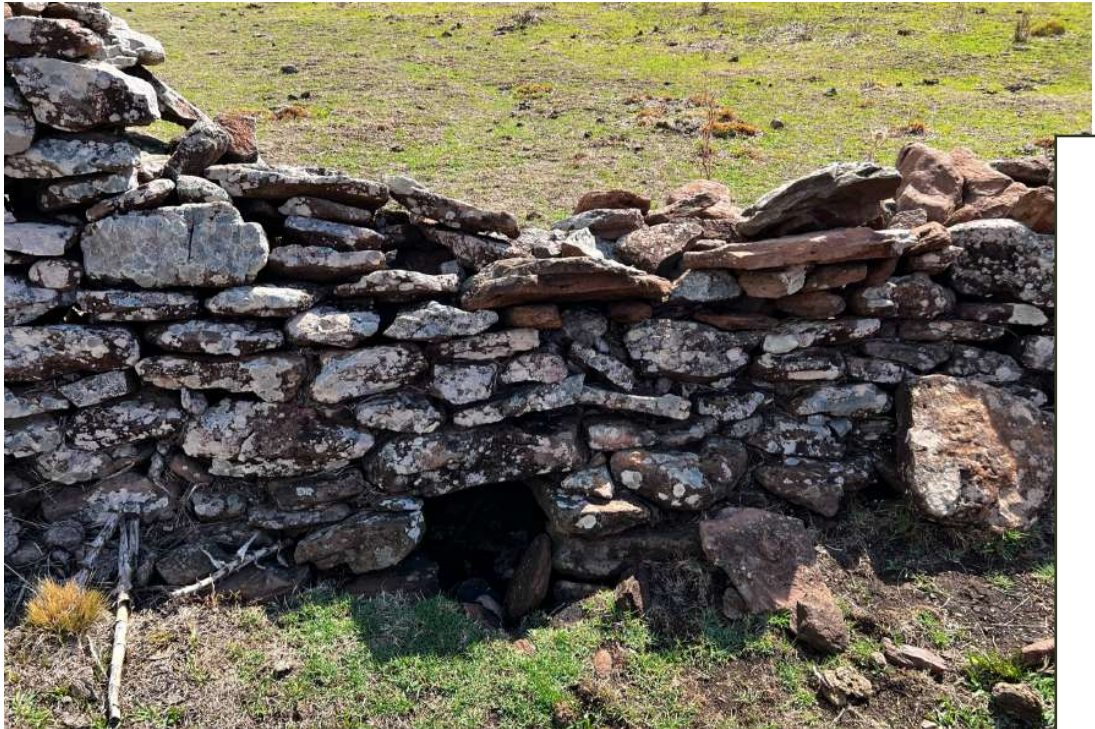
View of obstructed drainage system at a collapsed section of stone wall at Estancia Buen Retiro. Note that the top part of this section was reconstructed by farm workers with different color stones.

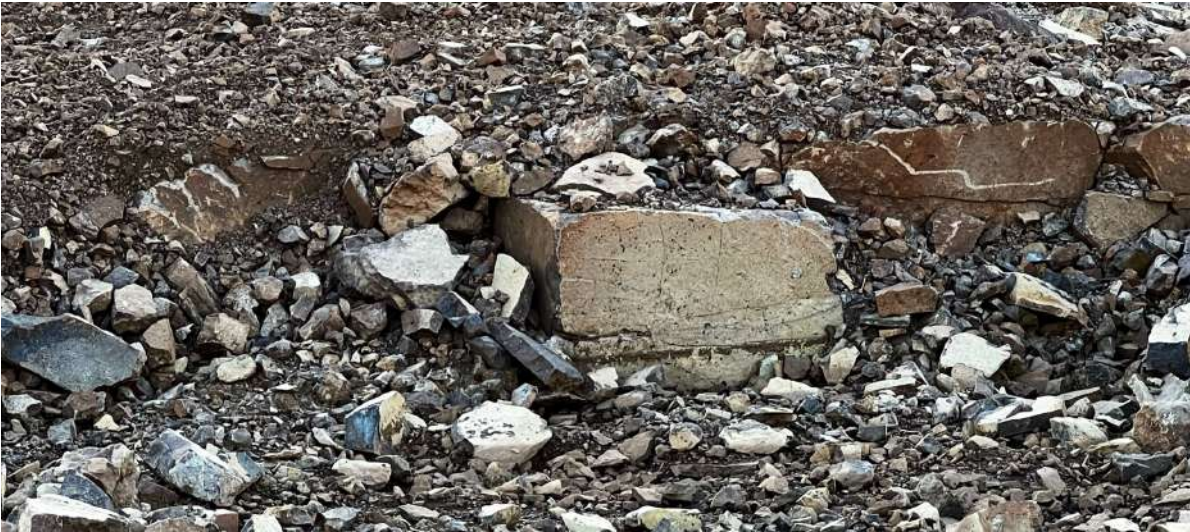
Soil formation with basalt rocks at the surface level that explains the widespread use of stone walls as fences around the region.
